**ALABAMA HAZARDOUS WASTES MANAGEMENT AND MINIMIZATION ACT  
(AHWMMA)**

**Compliance Evaluation Inspection (CEI) Report**

Sejong Alabama, LLC  
450 East Old Fort Road  
Fort Deposit, Lowndes County, Alabama 36032

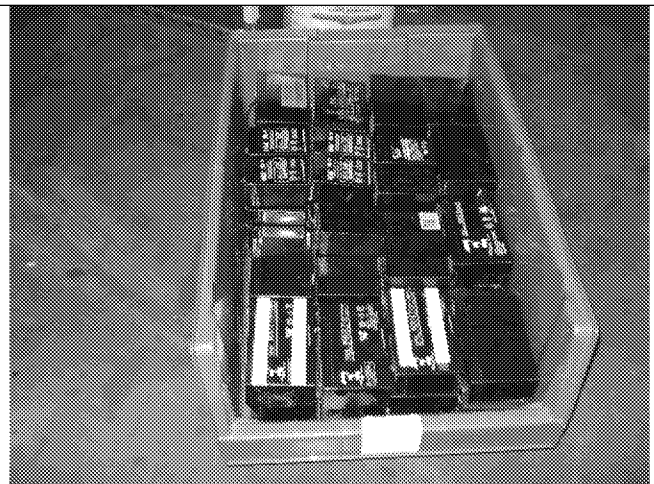
- The four boxes containing UW lamps were not marked or closed (the flaps were not closed or sealed);
- The uncontained HID lamp was placed on top of the box containing the broken lamps. It appeared to be intact, but was not marked in any way. Representatives of Sejong were not sure if this lamp was a waste (it was subsequently managed as UW);
- The drum that contained the spent paint pens was closed, but was not marked with the words “Hazardous Waste”. The pens contain xylene and are disposed as a hazardous waste;
- The containers holding the UW Ni-Cad and Lithium ion batteries were both closed and marked appropriately, but were not dated;
- The UW lead-acid batteries were intact, but were not marked or dated;

3. Universal waste lead-acid batteries

*In an email dated March 23, 2016, Mr. Blake Miley provided documentation that these issues had been addressed. All UW items were contained, labeled and dated; all hazardous wastes were correctly marked.*

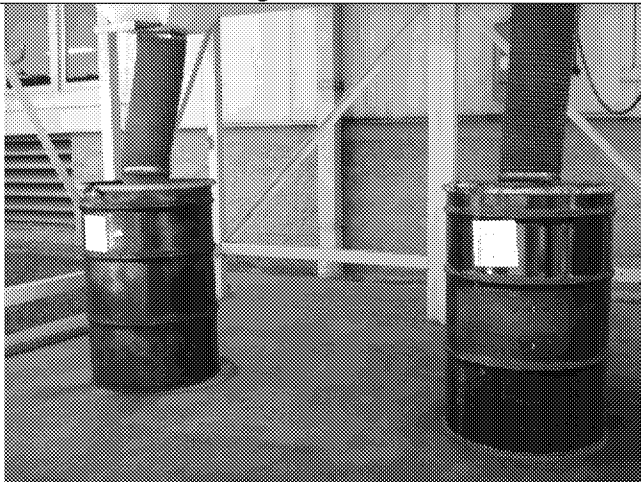
The “WCC” unit, located along the east wall of the plant between the “UD” unit and the “#4” unit, had two partially filled 55-gallon drums. Both were marked with the words “Hazardous Waste” and were closed, but the lids appeared to be significantly rusted. Again, the “return air” duct was vented to the outside to make it easier to control the air temperature in the vicinity of the unit.

12. WCC Baghouse

*In an email dated March 23, 2016, Mr. Blake Miley provided documentation that these issues had been addressed. All full containers were moved to hazardous waste storage, the rusted containers and lids have been replaced, lids that shed water have been ordered, and all drums are correctly labeled.*

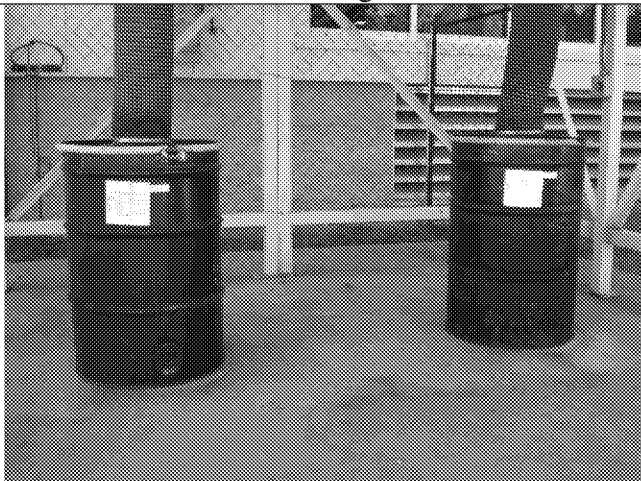
The “#4” unit, located near the south east corner of the building, had two full 55-gallon drums attached to the unit. Both were marked with the words “Hazardous Waste” and were closed. The drums did not show any significant amount of rust.

14. 4<sup>th</sup> Baghouse

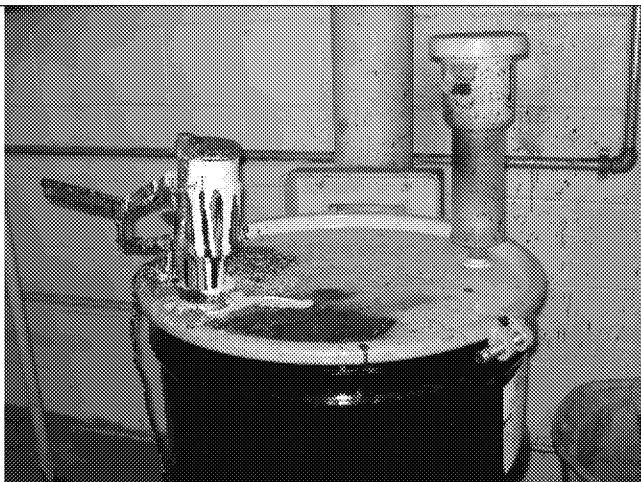
The satellite accumulation container equipped with the aerosol can puncture device was closed, labeled with the words “Hazardous Waste”, and appeared to be in good condition.

16. Maintenance Shop - Aerosol can puncture unit

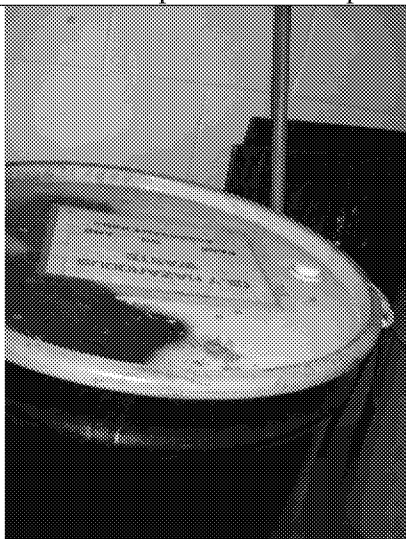
The 55-gallon open-top drum holding the oil-saturated material was closed and in good condition, but was not marked with the words “Used Oil”. Instead, it was labeled with the words “Oily Hazardous Waste”.

18. Maintenance Shop - Oil saturated sorbents

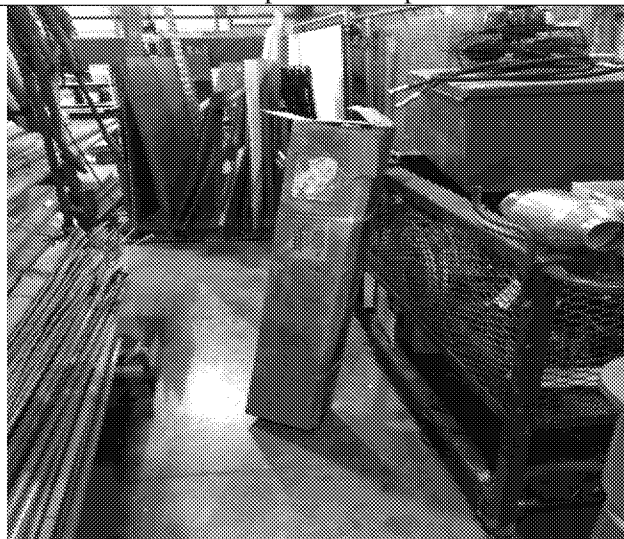
The UW lamps were stored in a corrugated cardboard box; the box was not closed and was not marked or labeled with any of the required phrases that denote universal waste. The box was not dated and facility personnel were not able to state when the lamps became waste.

19. Maintenance Shop - Universal Waste lamps

*In an email dated March 23, 2016, Mr. Blake Miley provided documentation showing that the container of UW lamps was closed, marked, and dated.*
